**Flood Control Project Maintenance  
Levee Inspections****LMA District Cover Sheet****Spring 2013 Levee Inspection Results****Reclamation District No. 2091 Chase**

**Levee Inspection Report By Mile - Spring 2013**

**Reclamation District No. 2091 Chase**

Waterway				Bank	Unit Miles	Inspection Start/End	Inspector	
Unit No. 01 San Joaquin River				Right	7.59	05/09/2013 05/09/2013	Richard Willoughby

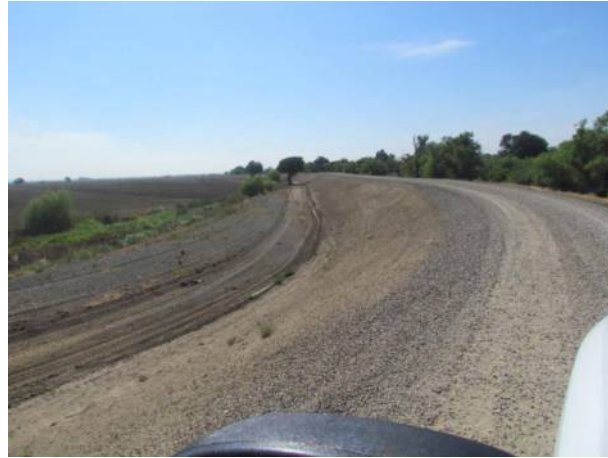
Levee Mile Report Line	4
Start Levee Mile	0.00
End Levee Mile	7.59
Location	Land Side
Category	
Item	Vegetation

Looking southeast at test for pre-emergent weed control on landward slope to control vegetation.

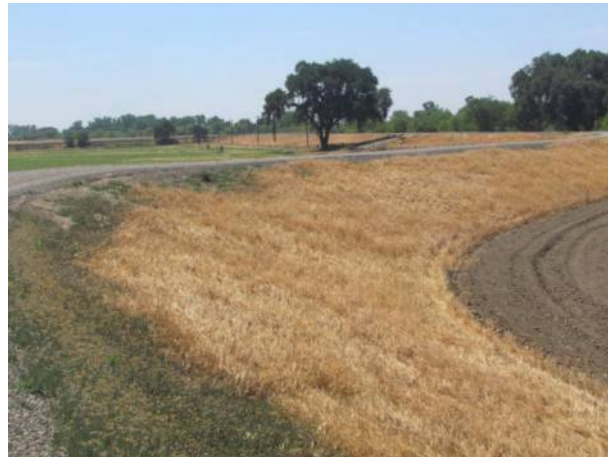
Levee Mile Report Line	5
Start Levee Mile	0.00
End Levee Mile	7.59
Location	Water Side
Category	
Item	Vegetation

Looking southwest at typical view of waterward slope.

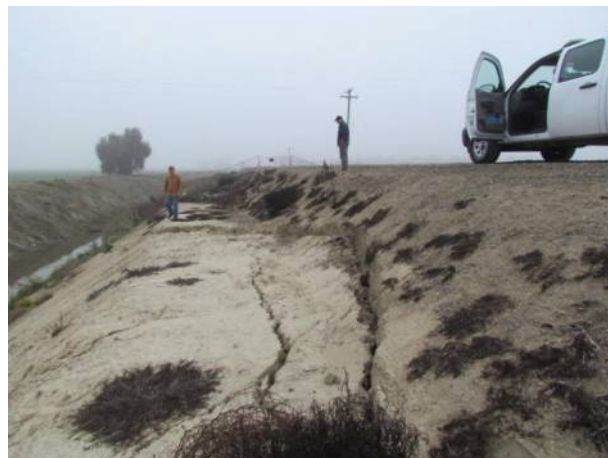
Levee Mile Report Line	9
Start Levee Mile	7.55
End Levee Mile	7.55
Location	Land Side
Category	
Item	Slope Stability

Looking south at slide on landside slope next to irrigation ditch.

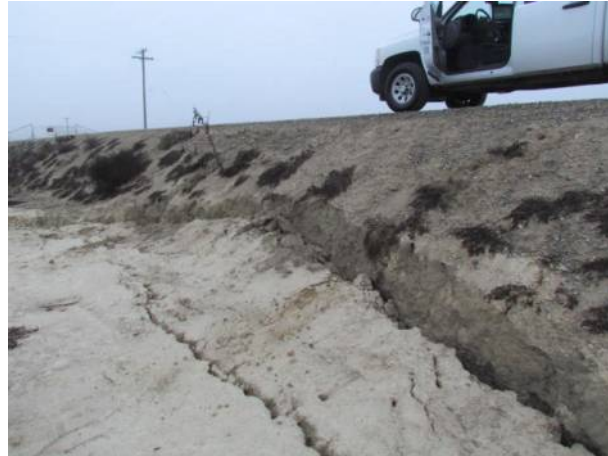
Levee Mile Report Line	9
Start Levee Mile	7.55
End Levee Mile	7.55
Location	Land Side
Category	
Item	Slope Stability
Looking southwest a slide on landside slope.	
richard_s_20130304_964.jpg

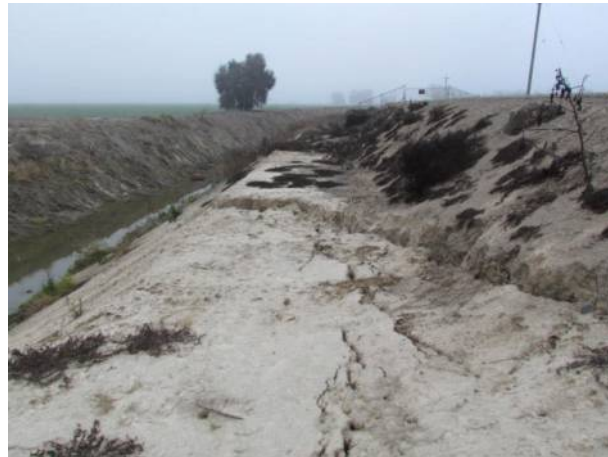
Levee Mile Report Line	9
Start Levee Mile	7.55
End Levee Mile	7.55
Location	Land Side
Category	
Item	Slope Stability
Looking at south end of slide.	
richard_s_20130304_965.jpg

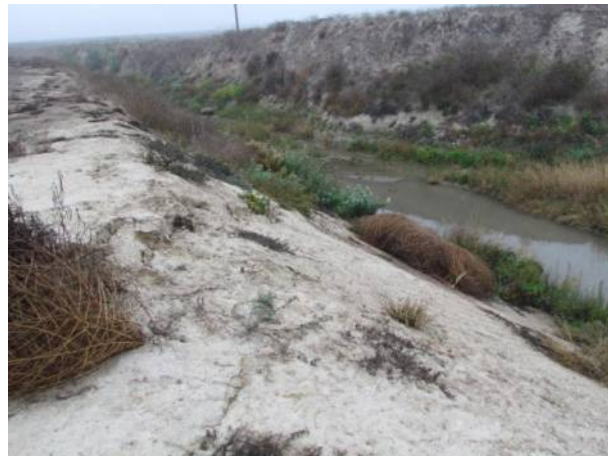
Levee Mile Report Line	9
Start Levee Mile	7.55
End Levee Mile	7.55
Location	Land Side
Category	
Item	Slope Stability
Looking at north end of slide next to irrigation ditch.	
richard_s_20130304_966.jpg

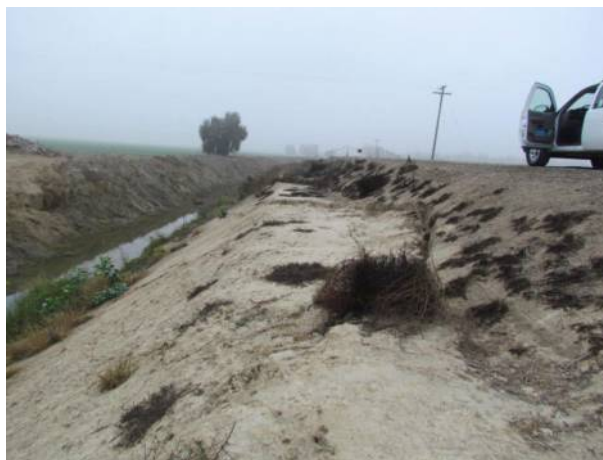
Levee Mile Report Line	9
Start Levee Mile	7.55
End Levee Mile	7.55
Location	Land Side
Category	
Item	Slope Stability

Looking south at irrigation ditch at landside toe.

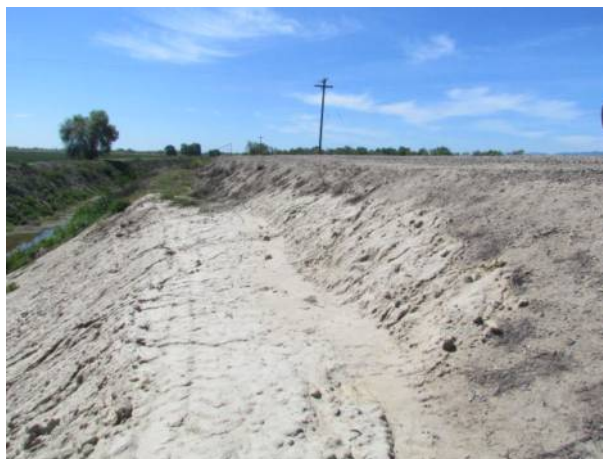
Levee Mile Report Line	9
Start Levee Mile	7.55
End Levee Mile	7.55
Location	Land Side
Category	
Item	Slope Stability

Looking south at repaired erosion/slip on landside slope.

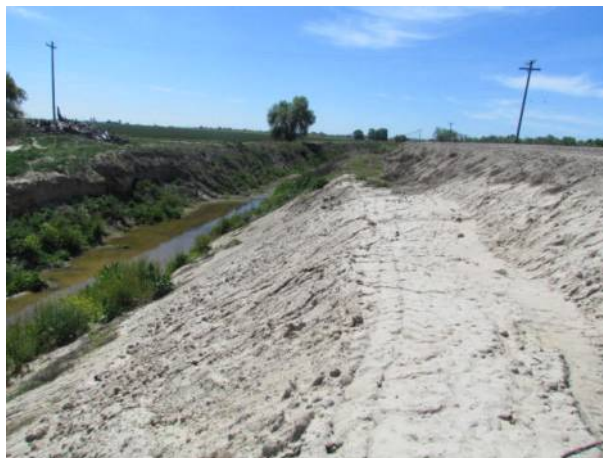
Levee Mile Report Line	9
Start Levee Mile	7.55
End Levee Mile	7.55
Location	Land Side
Category	
Item	Slope Stability

Looking southeast at repaired erosion/slip on landside slope next to irrigation canal.

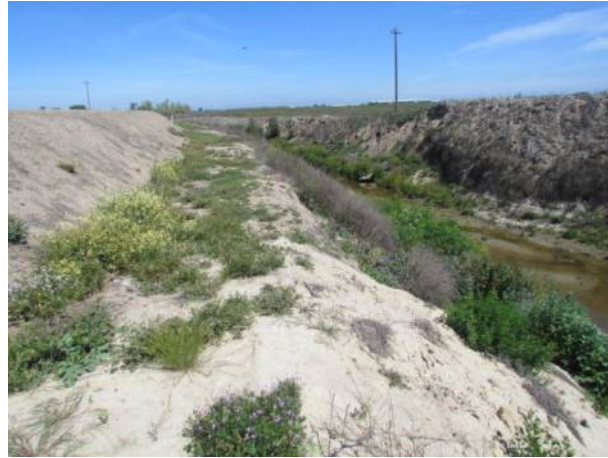
Levee Mile Report Line	9
Start Levee Mile	7.55
End Levee Mile	7.55
Location	Land Side
Category	
Item	Slope Stability

Looking north at repaired erosion/slip on landside slope next to irrigation canal.

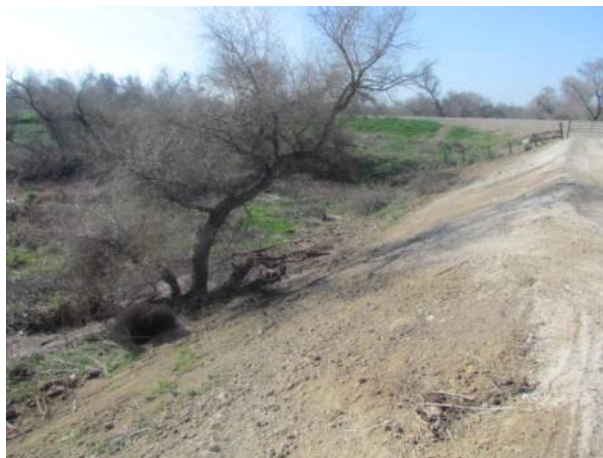
Levee Mile Report Line	1
Start Levee Mile	0.03
End Levee Mile	0.03
Location	Water Side
Category	
Item	Trim / Thin Trees

Looking west at trimmed tree on waterside toe. (Spring 2013)

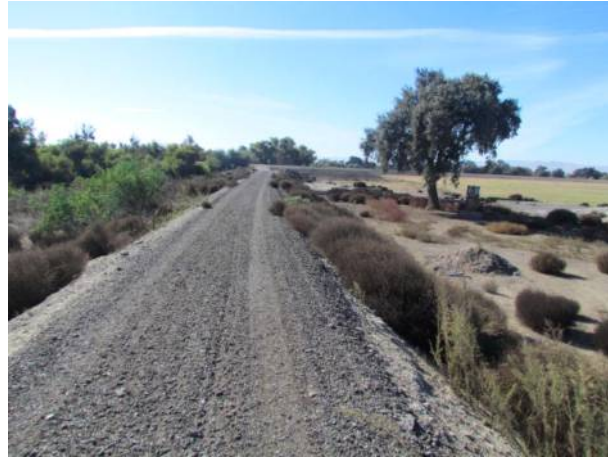
Levee Mile Report Line	2
Start Levee Mile	0.06
End Levee Mile	0.10
Location	Land Side
Category	
Item	Vegetation
Looking east at typical view of tumble weeds on levee slopes.	
richard_s_20130304_975.JPG

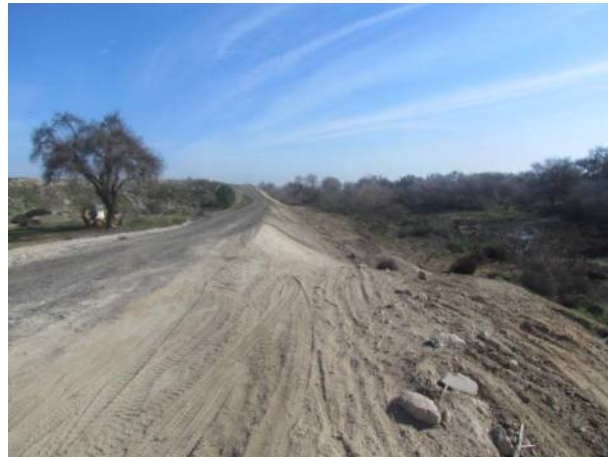
Levee Mile Report Line	2
Start Levee Mile	0.06
End Levee Mile	0.10
Location	Land Side
Category	
Item	Vegetation
Looking east at typical view of levee.	
richard_s_20130315_987.JPG

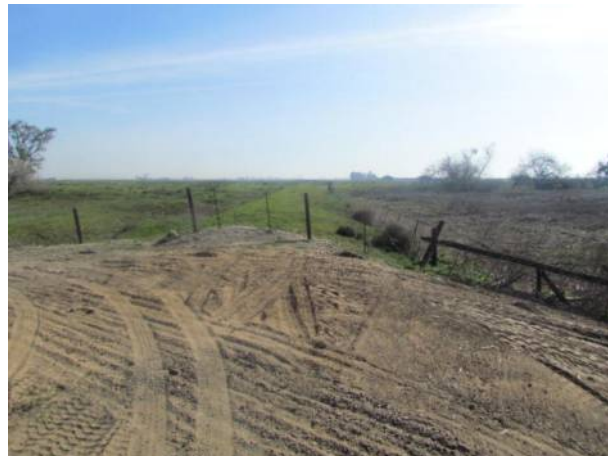
Levee Mile Report Line	3
Start Levee Mile	0.18
End Levee Mile	0.18
Location	Water Side
Category	
Item	Trim / Thin Trees
Looking southeast at the end of the project levee.	
richard_s_20130315_990.JPG

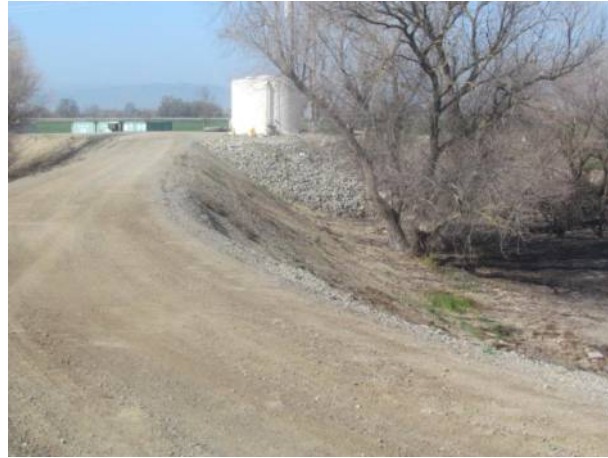
Levee Mile Report Line	4
Start Levee Mile	0.27
End Levee Mile	0.27
Location	Water Side
Category	
Item	Trim / Thin Trees
Looking east at trimmed tree on waterside toe.	
richard_s_20130315_988.JPG

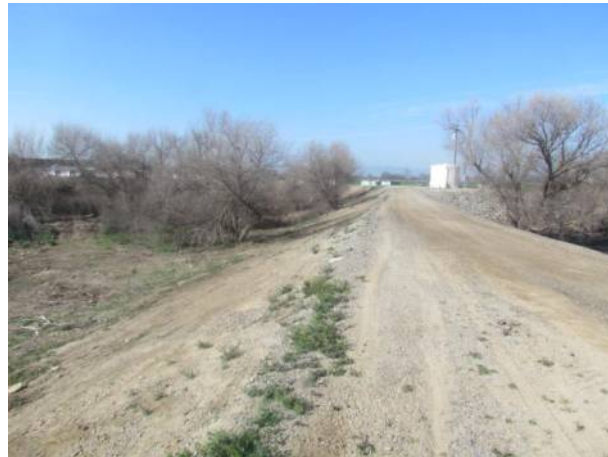
Levee Mile Report Line	5
Start Levee Mile	0.29
End Levee Mile	0.29
Location	Land Side
Category	
Item	Trim / Thin Trees
Looking east at trimmed trees on landside slope and toe.	
richard_s_20130315_989.JPG

5	0.29	0.29		Trim / Thin Trees	LS A/W Ma	T1	: Trim trees to at least five feet above ground level.	37.485447 ° -121.049750 °	37.485447 ° -121.049750 °	4 Y
DWR ID: DWR_RD2091_02_f_2012_4
